Certificate of Testing

Certificate Number: 2018/83

System: **Mechslip Brick slip system**

System supplier: Ash and Lacy Solutions Ltd
Bromford Lane
West Bromwich
West Midlands
B70 7JJ

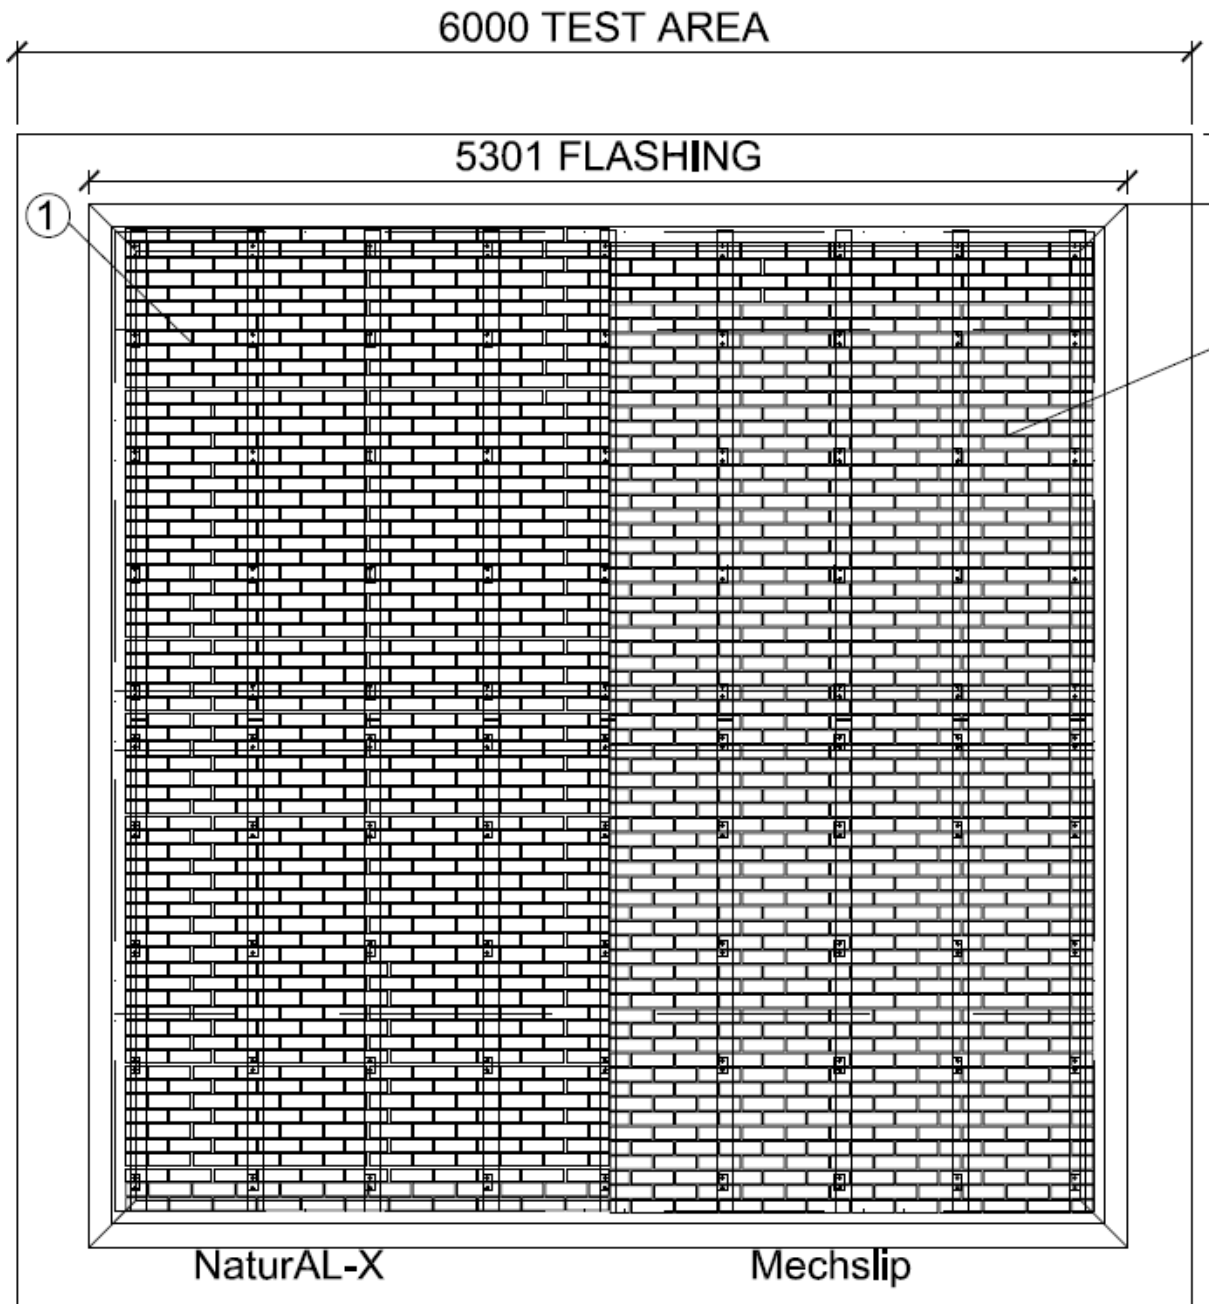
Elevation of test wall

Note: Test wall included two types of brick slip.
This certificate relates to the Mechslip system only.

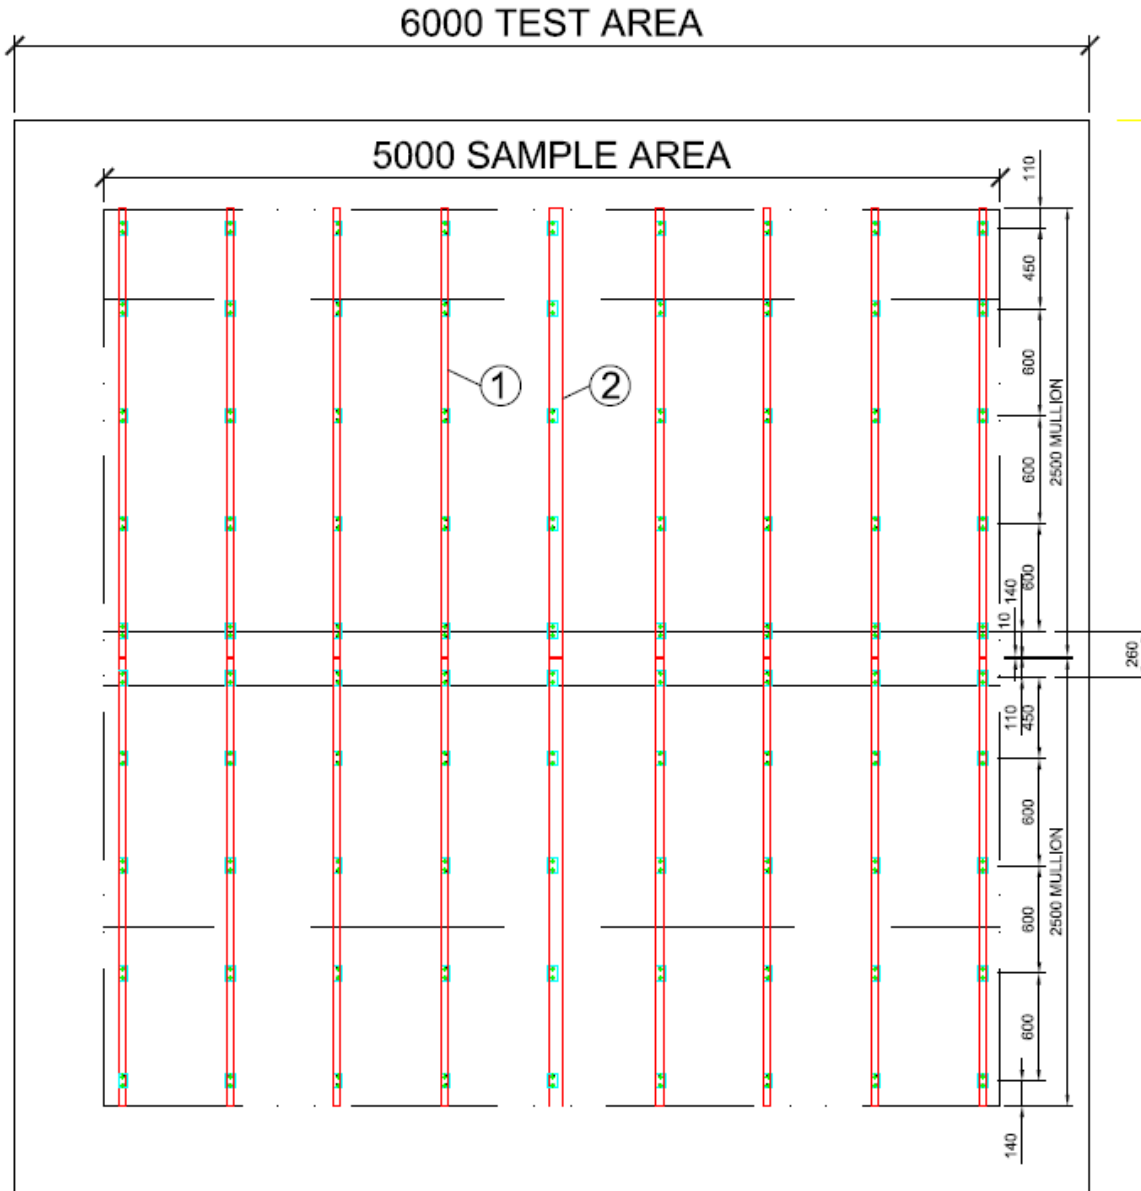
Key

1. 8 off M14 - L60X40X2.2 Rail, 2500 mm long
2. 2 off M15 - T60X80X2.2 Rail, 2500 mm long

Elevation of test wall showing support rails and bracket locations

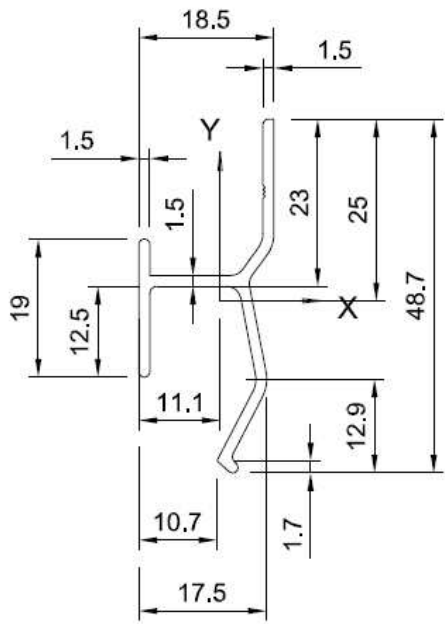
Horizontal rail

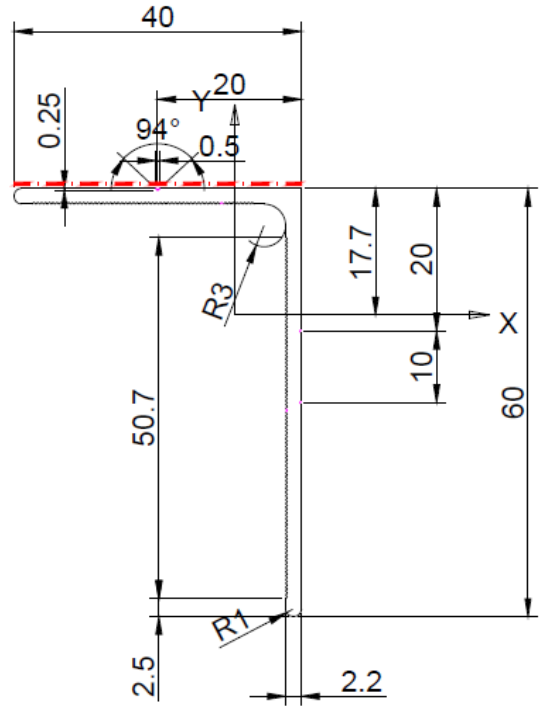
Vertical rail

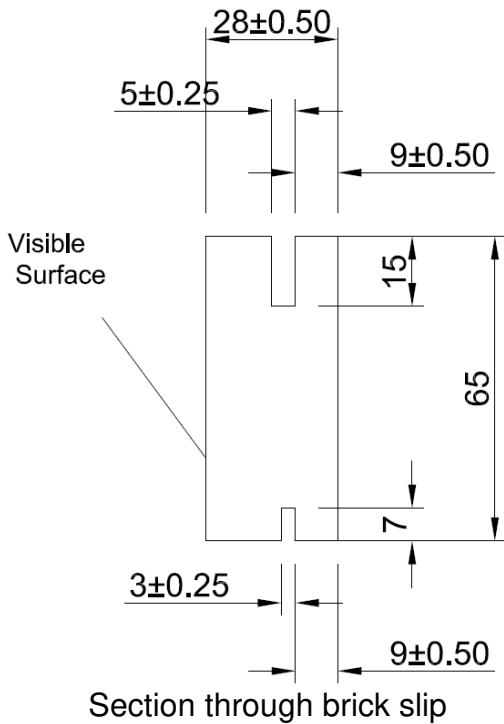
Section through brick slip

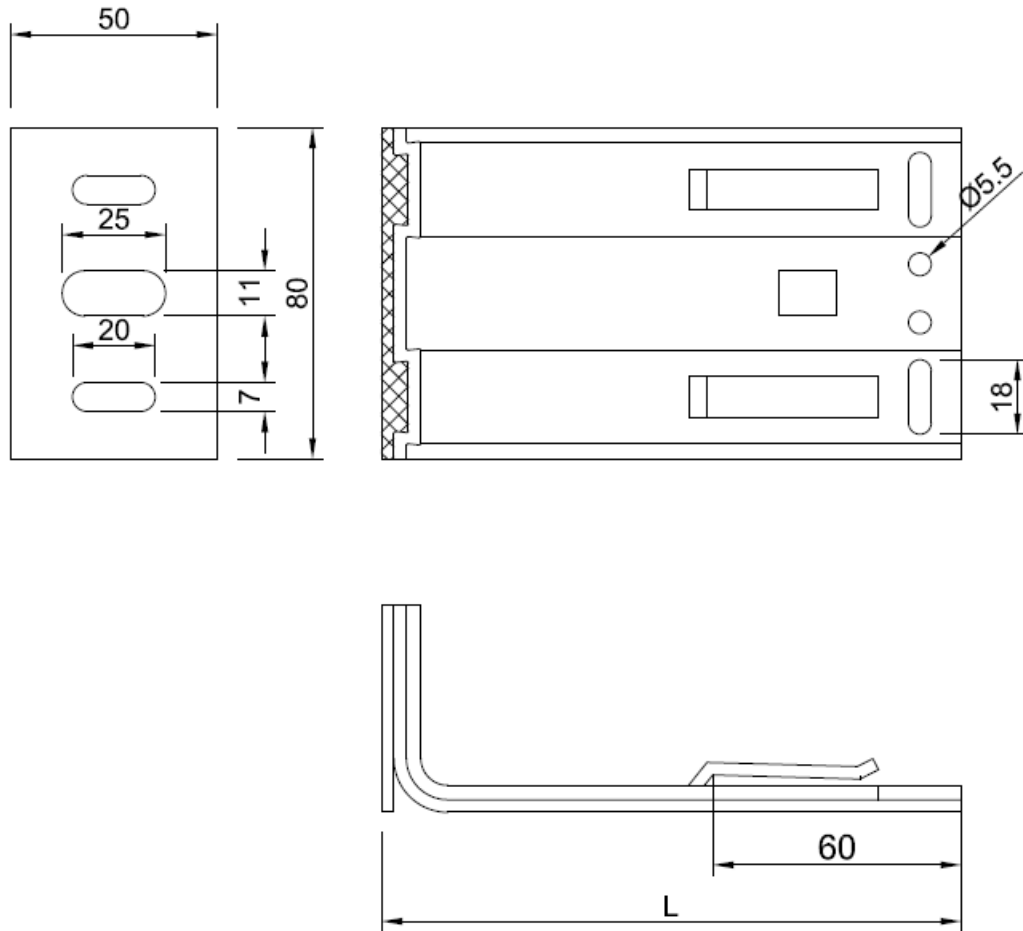
Bracket Ref	L (mm)	Components in Assembly
HB090S-TP	90	HB90S+TP80L
HB120S-TP	120	HB120S+TP80L
HB150S-TP	150	HB150S+TP80L
HB180S-TP	180	HB180S+TP80L
HB210S-TP	210	HB210S+TP80L
HB240S-TP	240	HB240S+TP80L
HB270S-TP	270	HB270S+TP80L
HB300S-TP	300	HB300S+TP80L

Bracket details

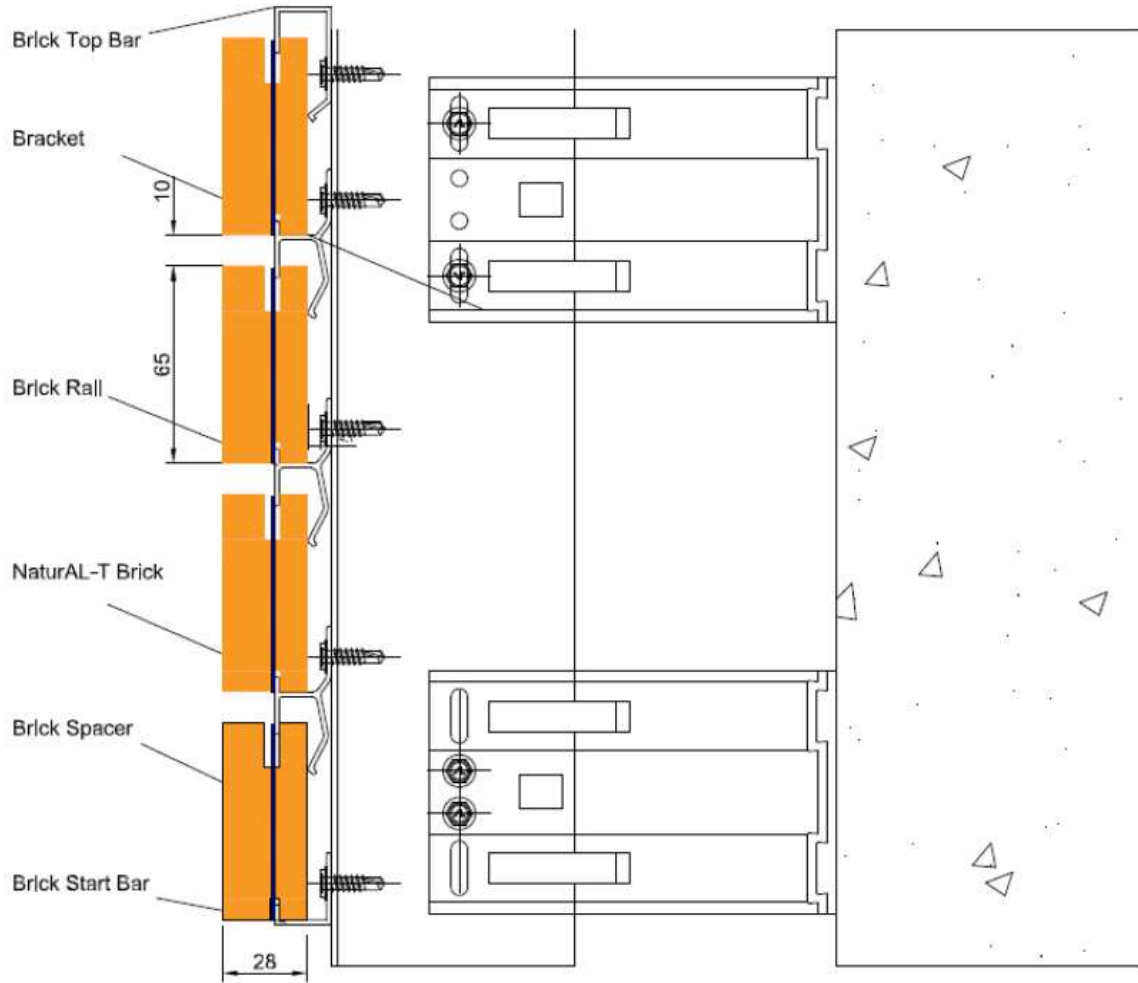
Section through system showing typical fixing arrangement

Fixings: Brick slips engage with horizontal rails and locked in position by mortar joints. Horizontal rails fixed to vertical rails with screws, one screw at each intersection. Rails fixed to brackets by screws, two screws per bracket. Screws manufactured by Ash and Lacy and supplied as part of system.	
Drainage and ventilation: Note: The CWCT Standard requires a drained and ventilated cavity in a rainscreen wall which requires openings at the top and bottom of the cavity. The cavity is required to have a minimum width of 25mm. The Standard does not specify the minimum area of drainage and ventilation openings.	10mm diameter drainage holes provided at bottom of test sample.
Backing wall:	Steel studs with plywood sheathing. Back wall provided to facilitate testing but not part of the tested system.
